**TAUNTON RIVER BASIN
TAUNTON, MASSACHUSETTS**

**MILL RIVER DAM
MA 00813**

**PHASE I INSPECTION REPORT
NATIONAL DAM INSPECTION PROGRAM**

APRIL 1979

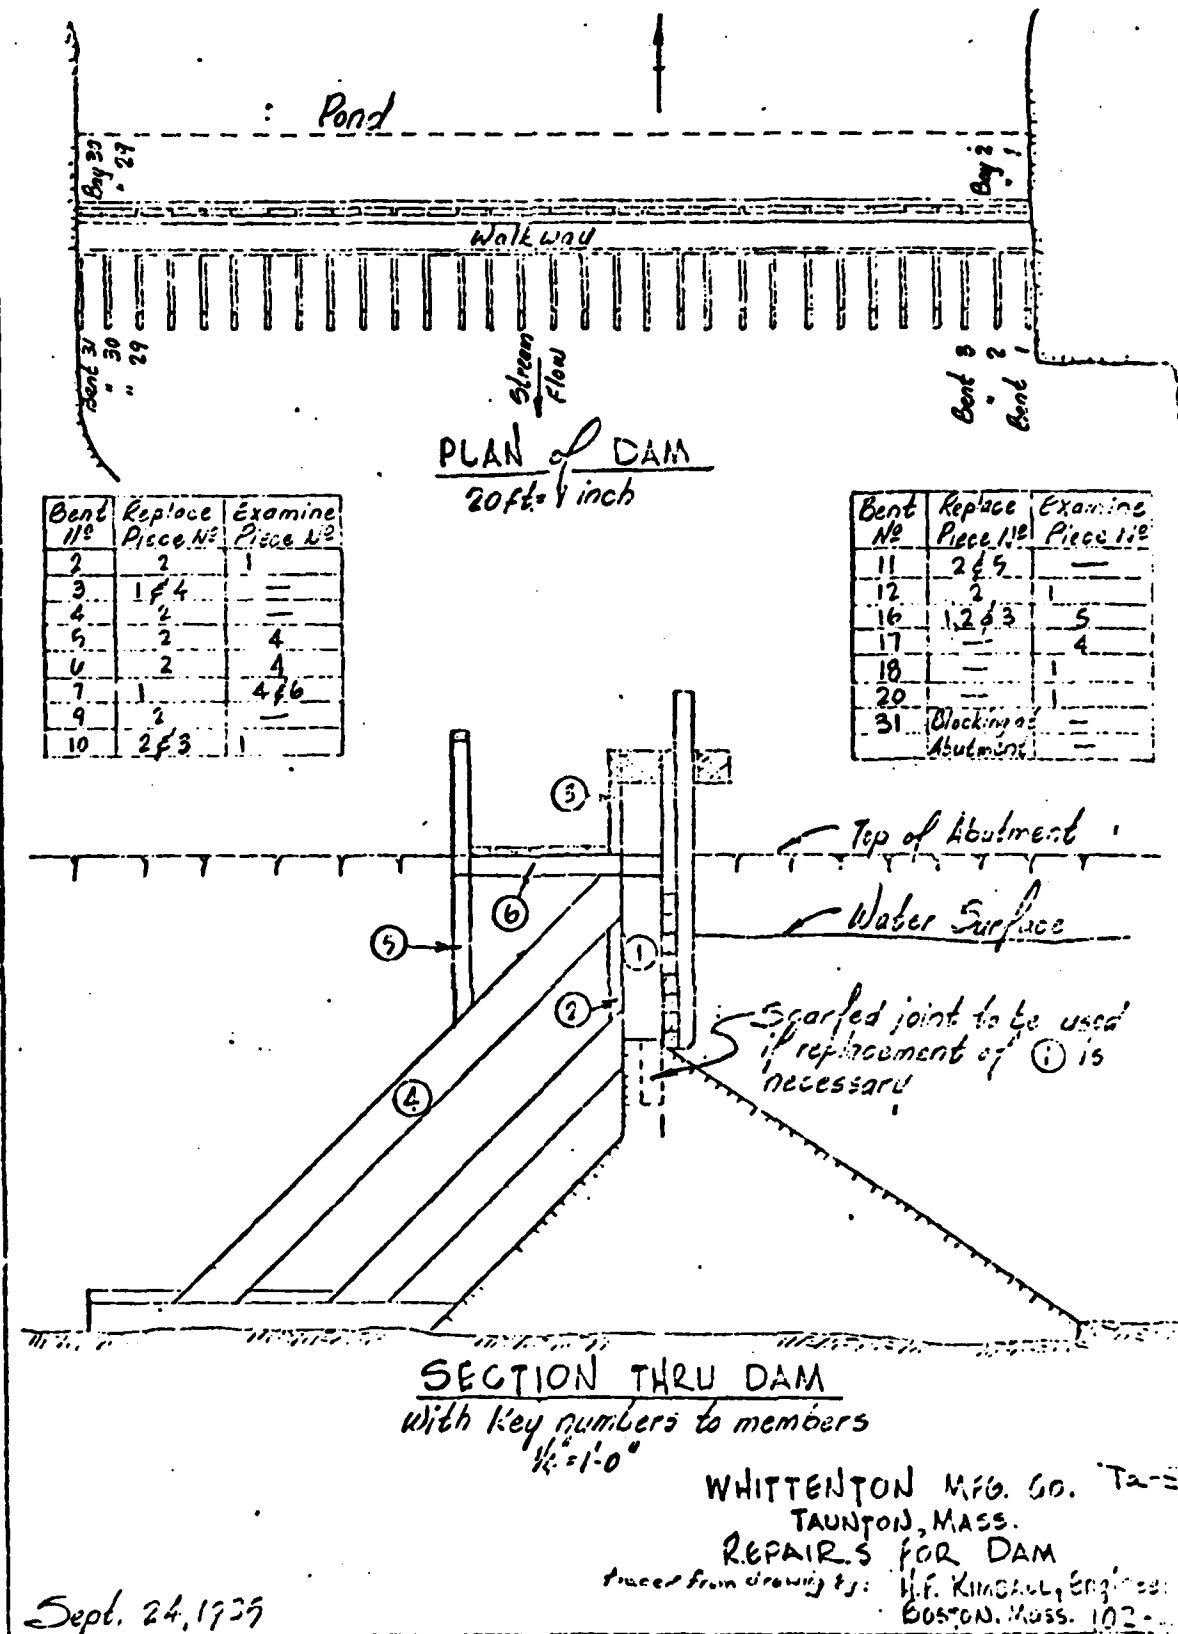
FIGURE B-3

- 2.1 General. A drawing dated September 1935 is available from the Bristol County Commissioners Office and shows proposed repair of timbers on the dam (see Figure B-3). A report on hydraulic and stability analyses conducted for Mill River (Whittendon) Dam was prepared by Metcalf & Eddy, Inc. The report is dated June 1973 and copies are available from the Owner and from Metcalf & Eddy, Inc. No other plans, specifications, or computations are available from the Owner, State, or County agencies relative to the design, construction, or repair of this dam.

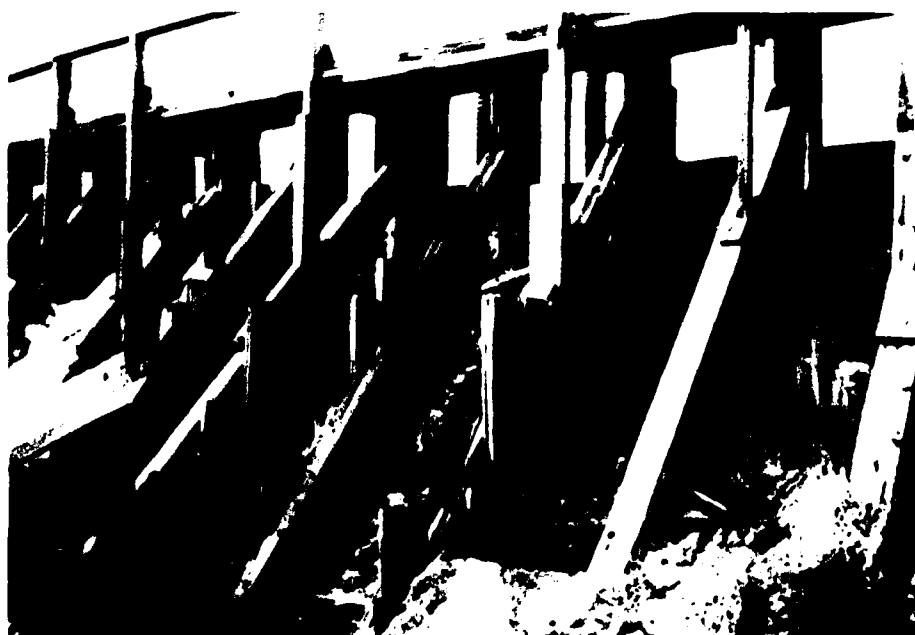
NO. 4 DETAIL OF DOWNSTREAM FACE OF DAM
